AUGUST 1964 THE NAVAL AVIATION SAFETY REVIEW

## POINT OF ORIGIN

## DESIGN SAFETY

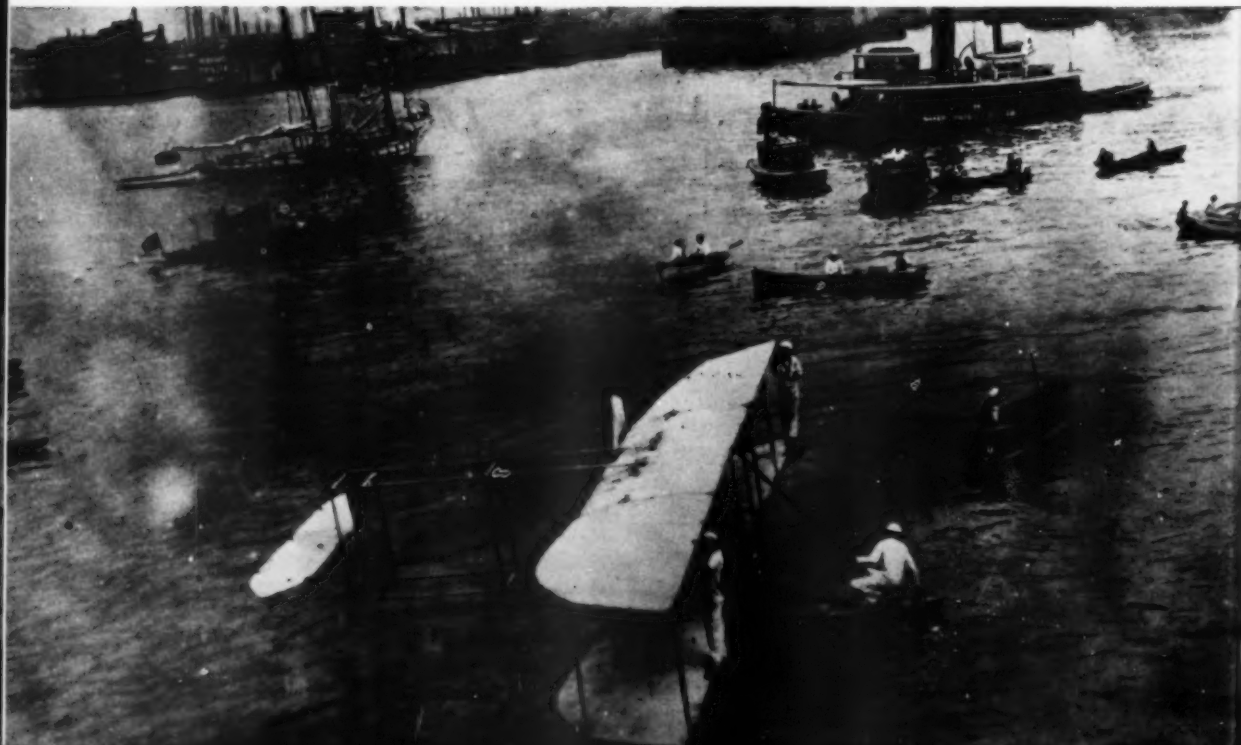
One of the first aircraft purchased by the Navy was a Wright landplane which was converted to a seaplane by installing a specially designed float. It is shown as it appeared afloat shortly after its conversion in 1911, in Baltimore Harbor.

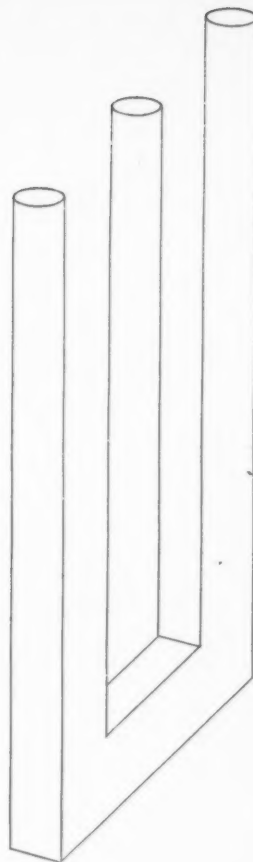
How many prongs?  
Are they round or square?

Look at the top of the figure—note the three round prongs.

But look at the bottom. . . ?
